## Cracks to metal buckles on Petzl Sequoia and Sequoia Swing Harnesses

Issue date	12 <sup>th</sup> December 2015	Ref. No	UAG036
------------	--------------------------------	---------	--------

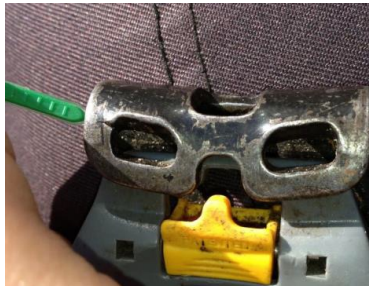
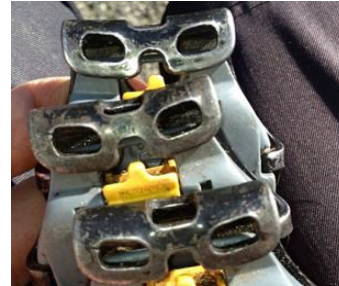
A UK based Network Operator has recently reported what appeared to be a small crack on the metal buckle component of two Petzl Sequoia and two Sequoia SRT harnesses, as below.

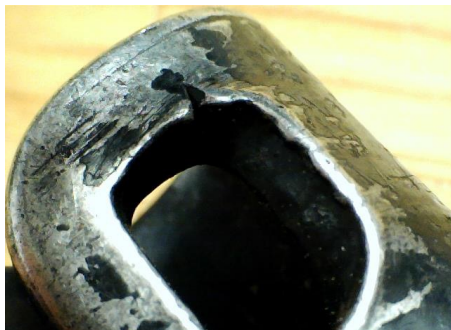
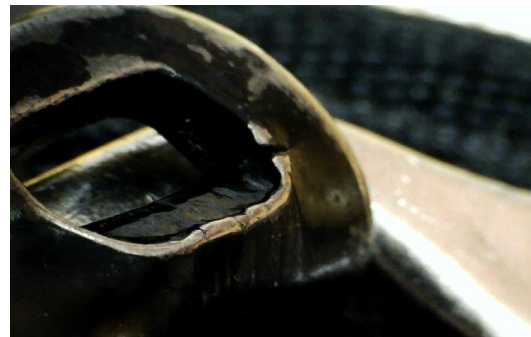
Closer inspection suggested the cracks may be splits in the fold of metal which may have formed due to wear. Over time as the buckle has worn it has developed a small lip/burr on the edge. It appears this is actually a small split or gap in this surface burr as opposed to a crack in the buckle.

The buckles on the harnesses were replaced and further investigated by Petzl, who have confirmed the marks appear to be cosmetic. They believe they will not affect the strength of the product as they are only on the surface, and is within acceptable tolerance.
