# Safety Bulletin

## ***Serious injury following contact with moving plant (JCB Tele-handler)***

Issue date	24 <sup>th</sup> April 2018	Ref. No	UAG055
------------	-----------------------------	---------	--------

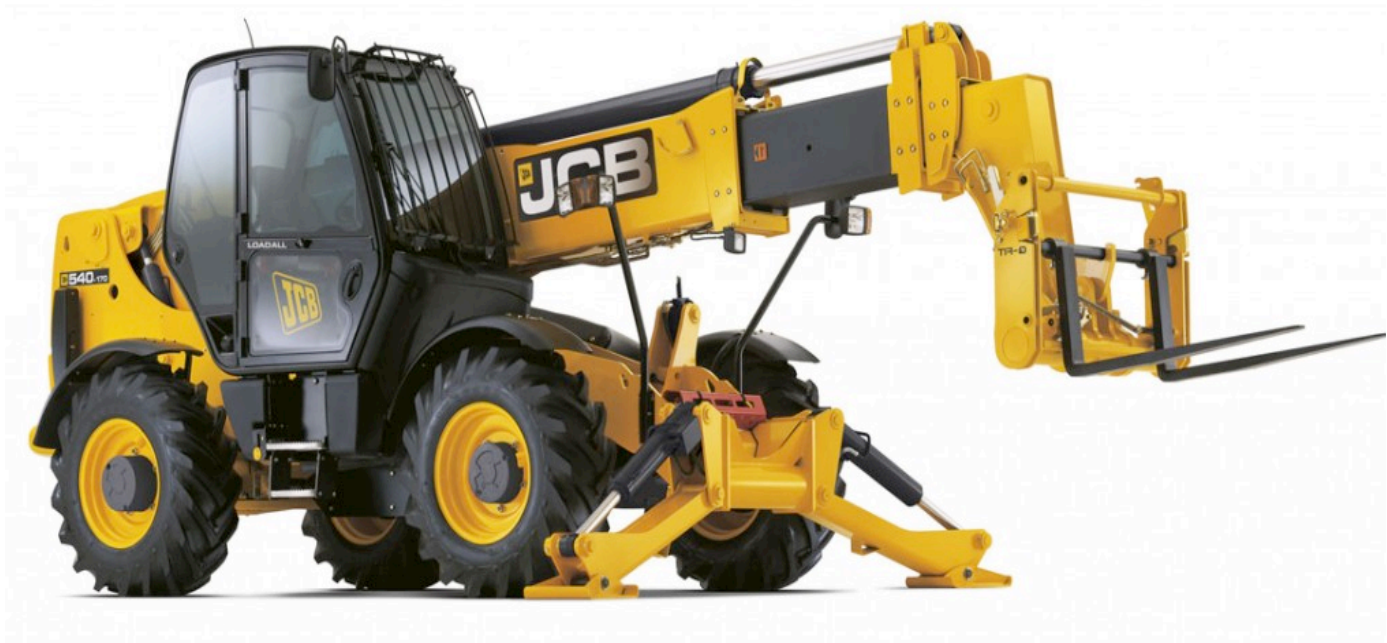
An operative was seriously injured when becoming trapped under the front fork assembly of a hired-in JCB tele-handler.

Whilst positioning a section of "bog-mat", the machine tipped forward, trapping the supervisor and causing serious injuries to their right leg, ribs and back that required several operations.

- Machinery was not used in accordance with the operating procedures.
- The operators did not have the correct competency for the planned operation in compliance with requirements of LOLER and BS7121.
- "Pre-use" checks were not carried out before the machinery was operated.
- The slope of the compound area was not recognised by the machine operator nor the slinger signaller.
- Communications between the machine operator and others including slinger/banksman or Machine Controller were not effective.
- The task was not controlled by a suitable briefing nor briefed to all persons involved in the activity.

- Check lift plans for all activities involving lifting of plant or equipment.
- Ensure that operator has the correct competency for the planned operation in compliance with requirements of LOLER and BS7121.
- Review similar activities either current or planned to ensure all are properly planned and briefed.
- Communicate the plan of work to ensure that all persons involved are aware of the controls required to carry out the task in a safe and competent manner.
