## Falling petrol auger drill causes serious injury

Issue date	02/12/ 2014	Ref. No	UAG012
------------	-------------	---------	--------

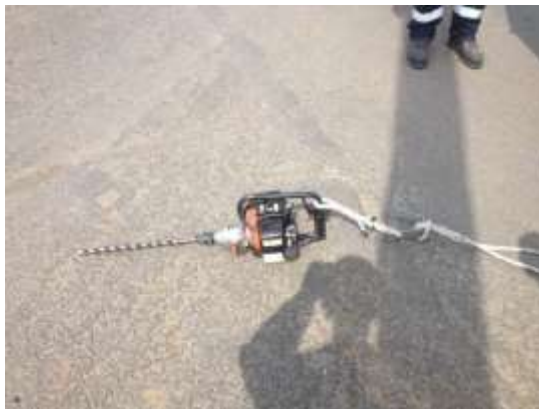
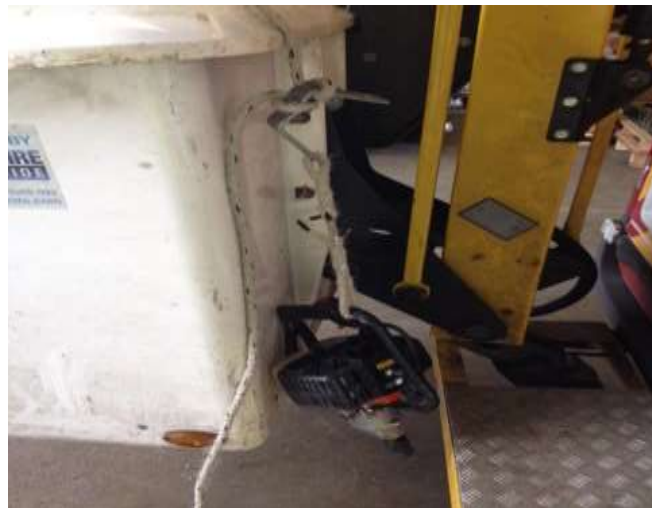
A team of linesmen and a joiner were involved in a LV overhead refurbishment scheme. The linesmen were using a MEWP, and were in the process of disconnecting an underground service at the top of a pole when a petrol driven auger, with the auger drill bit fitted, became detached from its temporary fixing to the outside of the MEWP bucket. The drill fell 4 metres and penetrated the joiner's neck, embedding itself roughly 8 inches, and narrowly missing his spine and heart. The injured joiner was admitted to hospital where the auger bit had to be surgically removed, and was in intensive care overnight. Mobility in his left arm is restricted due to the trauma, but is not expected to be permanent, but full rehabilitation is likely to be protracted.

1. Minimise the tools and equipment required when working at height
2. Ensure exclusion zones are established around the point of work
3. Nominate a dedicated person to control the work area (from the ground) while work is being undertaken at height
4. When working from a MEWP equipment should be stored inside the bucket. Do not fabricate temporary solutions to attach tools and equipment to the outside of the MEWP bucket
