Catastrophic failure of a hydraulic ram in a boom type MEWP

Issue date	14/05/15	Ref. No	UAG0017
------------	----------	---------	---------

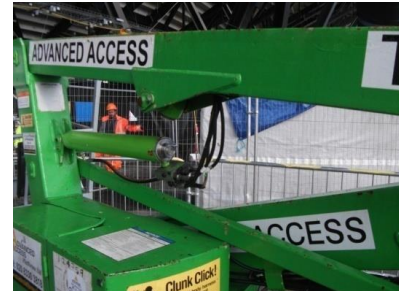
Steel erectors were working from a Nifty Lift HR12 Boom type MEWP at approximately 5 metres when the hydraulic ram which positions the lower boom sheared in a catastrophic manner resulting in the boom collapsing.

The initial investigation has identified that the weld connecting the head of the ram to the main body of the ram has failed. The cause of this is currently being further investigated, however, neither witness statements or CCTV footage of the incident indicate that the MEWP was struck immediately prior to the incident or during its time on site.

1. Thorough visual pre-use inspections of all equipment, as required, should be completed prior to use
2. If any signs of damage or defects are found a MEWP should be immediately quarantined, and further advice sought from your line manager or the MEWP supplier

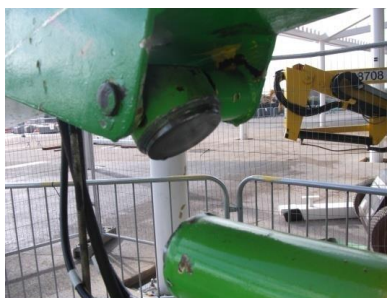
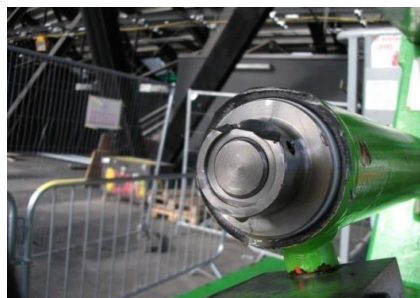
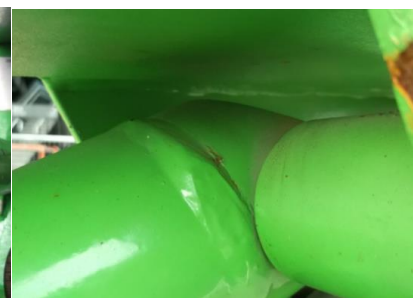
It is understood that the MEWP was 17 years old; however the ram was replaced two years ago and the last six monthly inspection had been completed in July 2014. An inspection of a similar MEWP on the site revealed a crack in the paint at a similar weld point.
