Safety Bulletin

All MEWP Operatives / Checks of MEWP Booms Recommended

Issue date	February 2018	Ref. No	UAG053
------------	---------------	---------	--------

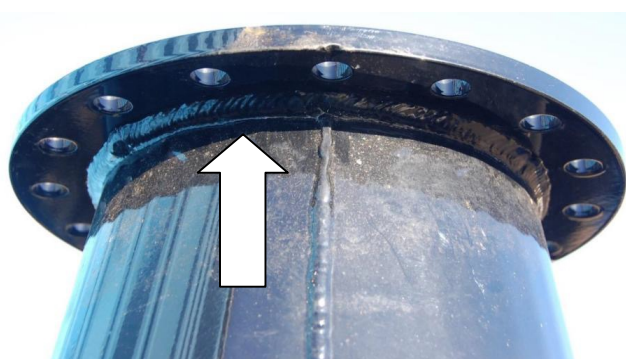
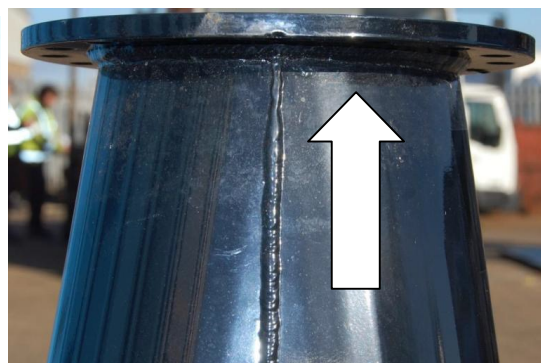
The cause of the incident has now been identified as an undetected fracture on the turret around the area below the flange weld. The crack was caused by multiple stress fractures around the turrets surface and the top part of the butt weld. The MEWP models associated with this include the Socage A314s mounted on Toyota Hilux's single cab and also the Isuzu D Max single cab vehicle platform. A service bulletin has been issued by the distributors Cumberland Platforms Ltd (CPL) to customers.

All MEWP operators should check on the turrets for signs of fractures or defects around the circumference surface, the flange weld and both the front and rear longitudinal butt welds (as indicated on the photographs below). It is imperative that this is carried out as part of the daily and pre-use checks along with all other structural and moving parts. If any defects are found the MEWP should be taken out of service and the defects reported immediately. All repairs must be done by manufacture prior to going back into service.

The manufacturers have recommended all customers be extra vigilant whilst carrying out routine inspections and have reminded customers that the MEWP must only be used for the purpose it was designed for and within its specified operating parameters.
