Issue Date	19 th February 2020	Ref. No.	UAG064
------------	--------------------------------	----------	--------

Train collision with tree near Spittal, Pembrokeshire, 17 October 2019

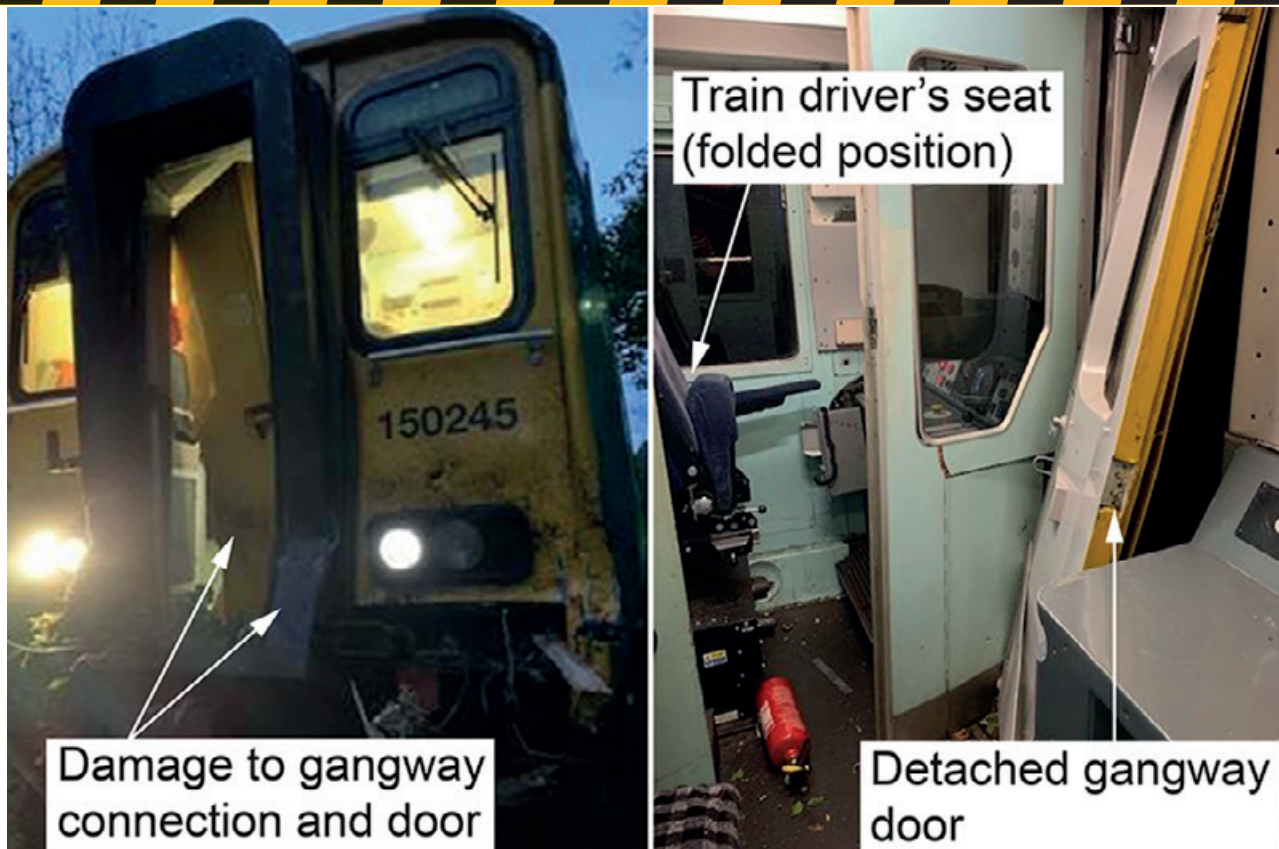
Damage to the train front and driving cab area (images courtesy of Network Rail)

At around 18:33 hrs on 17 October 2019, a train carrying 13 passengers and two crew members collided with a large oak tree that had fallen across the railway between the villages of Spittal and Treffgarne, Pembrokeshire. The train was travelling at around 55 mph (89 km/h), the maximum permitted speed at this location, when the collision occurred. Although the train did not derail, the front was badly damaged, and it was unable to continue its journey. The train driver suffered a minor injury and was left shocked by the accident.

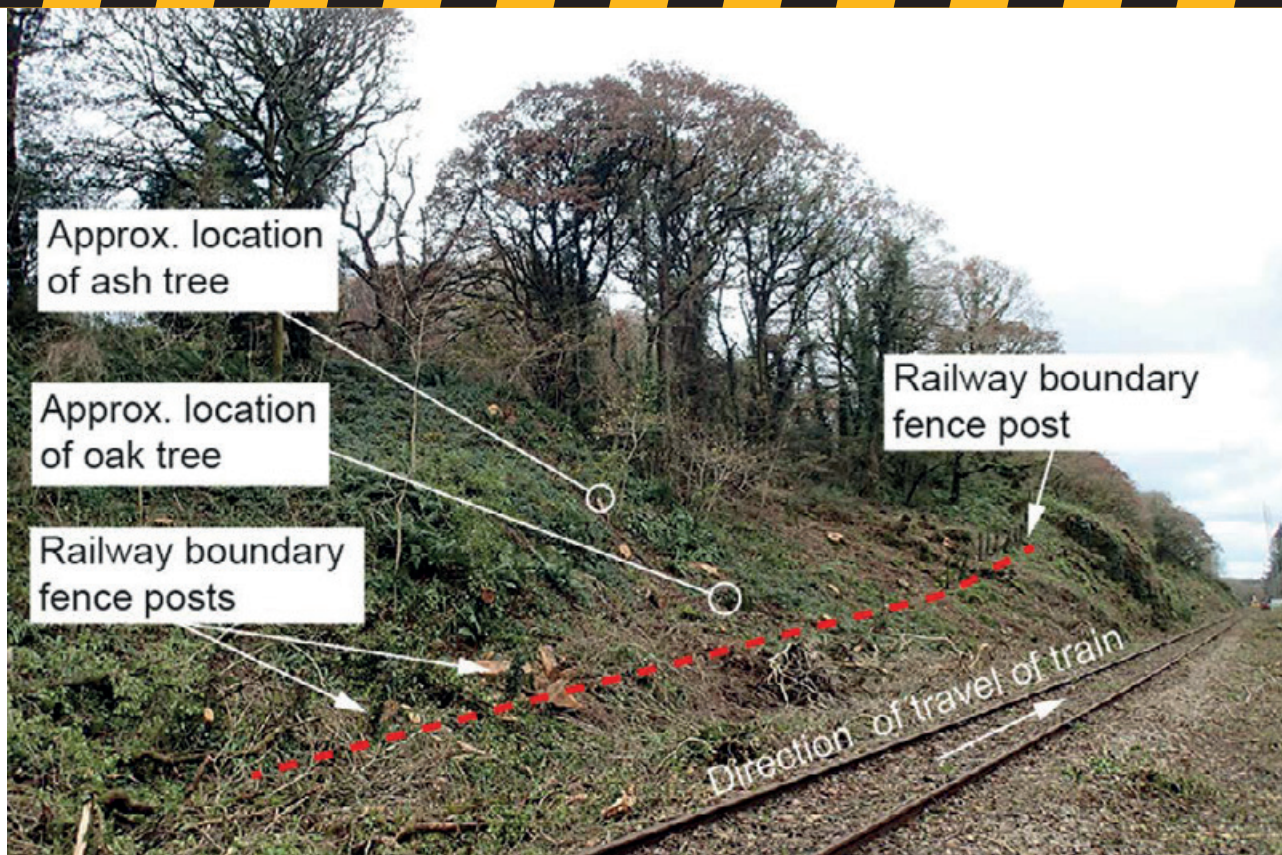
The tree that fell across the railway was an oak tree, estimated to be around 24 metres tall. It had grown around 8 metres from the railway track at a location about 0.4 metres outside the railway boundary fence. It fell because a diseased ash tree had fallen against it. The ash tree was around 21 metres tall and had grown about 12 metres from the railway track and about 4.4 metres outside the railway boundary.

Trees at the site of the accident, including those outside the railway boundary, have shallow root structures because they are growing in shallow soil on a rocky slope. The shallow root structure is the most likely reason that the oak tree fell after being struck by the ash tree.

Location of the oak and ash trees (dashed red line shows railway boundary)

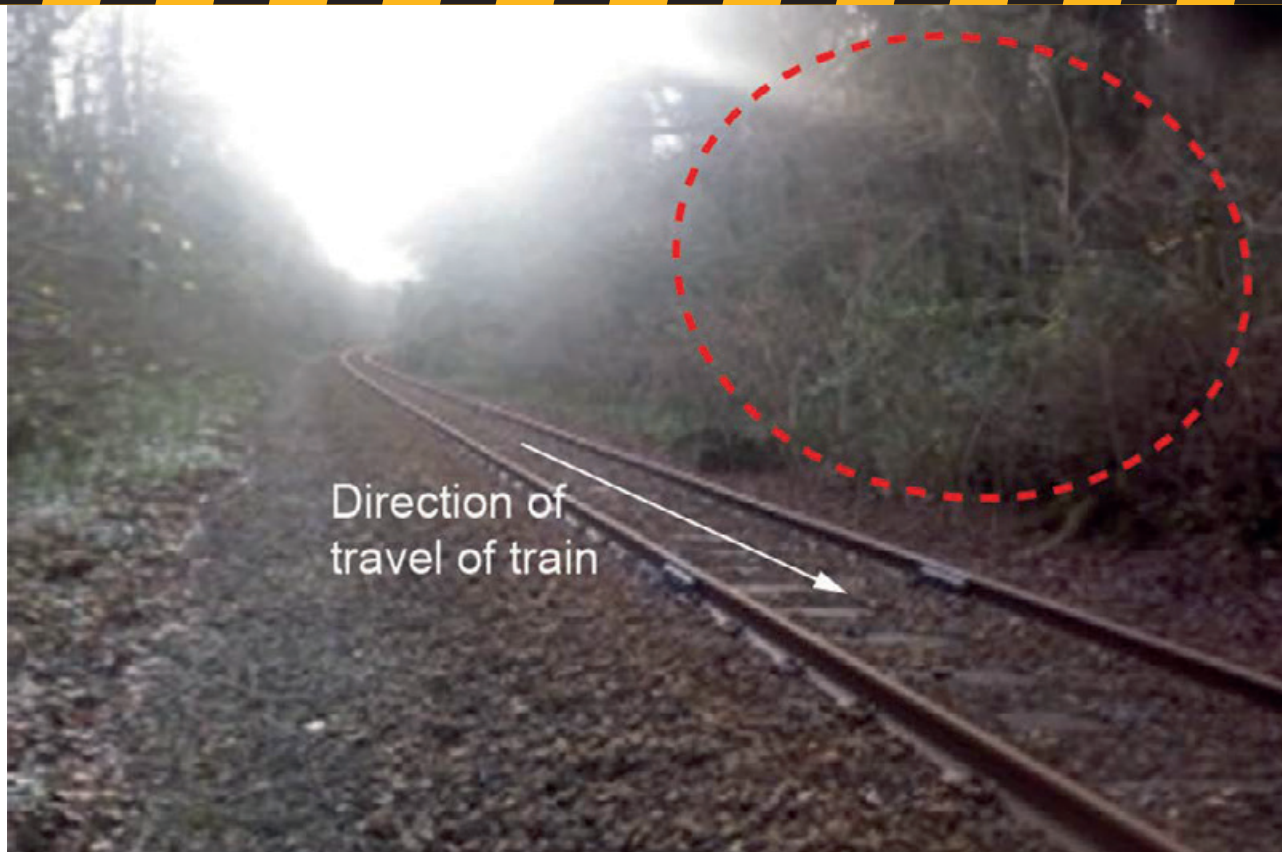
Although Network Rail procedures required tree inspections to include trees outside the railway boundary, the diseased part of the ash tree was near the ground and was probably not visible from within the railway boundary due to the presence of other vegetation. Access to the bottom of the ash tree would have been difficult due to underfoot conditions and other vegetation. In addition, Network Rail staff are not expected to walk outside the railway boundary when carrying out inspections as they do not have a legal right to enter neighbouring land for this purpose.

**Pre-accident image with dashed line showing area from which trees fell
(image courtesy of Network Rail)**

- Land owners adjacent to the railway inspecting trees on their land and taking appropriate action to ensure that they do not pose a risk to railway safety (Network Rail reported that it intends to publish guidance to land owners on its external website by the end of February 2020).
- Railways knowing, where practicable, who owns and occupies neighbouring land where there is a risk of trees falling onto the railway, and providing information to them about the danger to the railway due to falling trees.
