Fatal incident involving two French linesmen

Issue date	16 th March 2015	Ref. No	UAG014
------------	-----------------------------	---------	--------

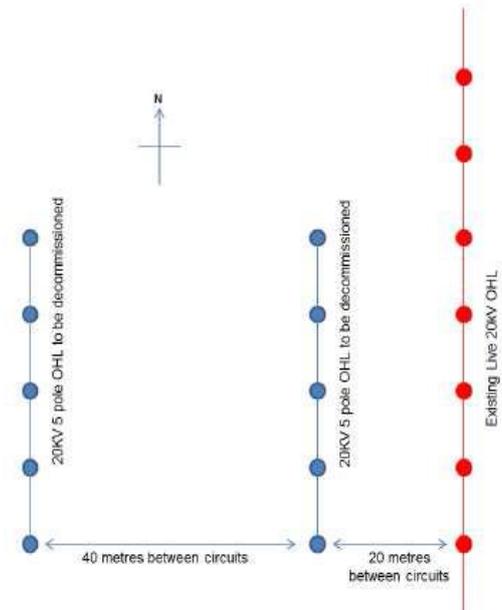
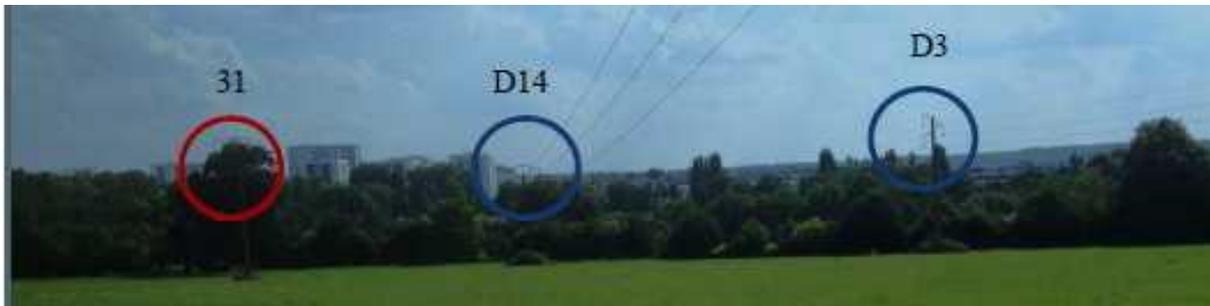
In the immediate vicinity were 3 separate overhead line circuits running at 20kV, parallel to each other. An outer and middle circuit some 40m apart, where both de-energised and due to be recovered (shown in blue). A third line running in parallel was energised and in service. All the circuits were in farmland and between two of the circuits was a small wood, which prevented line of sight identification. The diagram (right) and the photograph (below) show the three separate circuits and the distance between them.

The Project Manager instructed the linesmen from his office using a plan as reference. The men then drove to site parking their MEWP alongside the circuit they thought was isolated ready to commence decommissioning works. At this stage it is not known why the linesmen accessed the live line in their MEWP but the result was that both linesmen received a fatal electric shock. The men were discovered by another overhead line team. There was no voltage tester found at the scene.

1. When working adjacent to parallel circuits a SAP must be appointed to be responsible for electrical safety and issue appropriate Safety Documentation on site
2. Linesmen must ensure they have proved the circuit dead and earthed the line, or be in sight of an existing portable earth applied to the line prior to starting work
3. The PTW holder is responsible for ensuring staff under their control are competent, authorised for the work in hand, and understand the work content including the operational status of adjacent equipment. This is an essential part of the Risk Assessment and formal set to work routine
