Mobile Elevating Work Platform (MEWP) malfunction

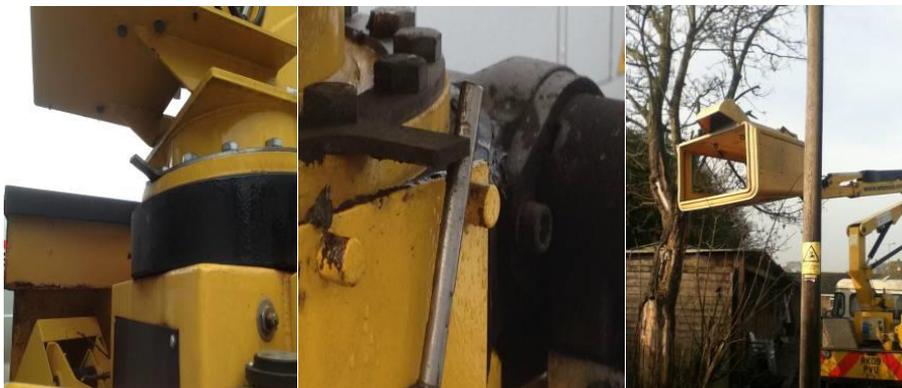
An arborist was commencing work in a Land Rover MEWP at a height of around 8 feet above the ground the bucket slowly tilted backwards under its own power. A harness and a restraint lanyard were being worn, so the arborist was able to exit the bucket safely.

The vehicle was fitted with a slew ring striker arm, which prevents rotation beyond 360 degrees and damage to the hydraulic system. This has been previously damaged, so it failed to engage the stop switch, and caused damage to the hydraulics. The damage was probably caused over a period of time, due to incorrectly stored materials on the bed of the MEWP.

1. Keep the bed of MEWPS clear of stored materials, rubbish and tree cuttings
2. Put tools and equipment away in designated tool lockers
3. Carry out pre use inspections of machinery and if faults are found report them
4. Ensure there is a site specific Emergency action plan
