## Collapse of a pole while linesman at work

Issue date	16 <sup>th</sup> July 2015	Ref. No	UAG022
------------	----------------------------	---------	--------

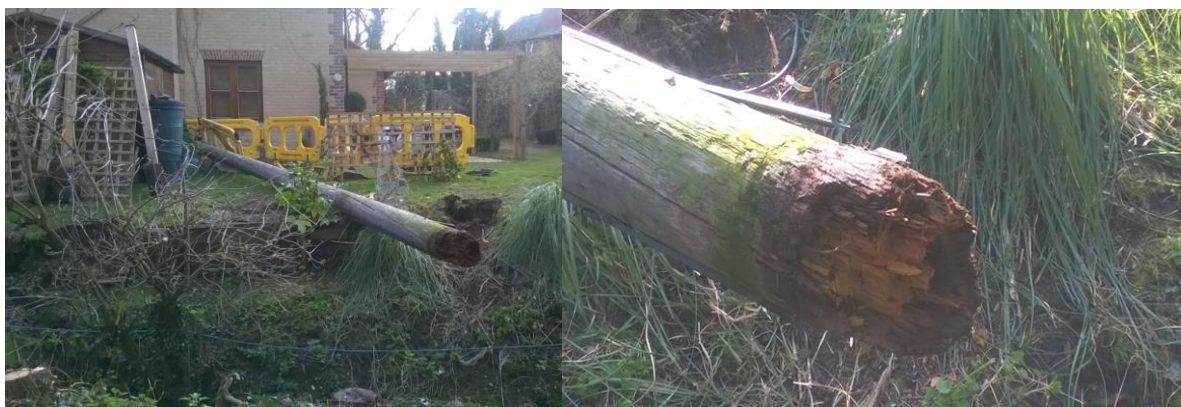
Thorough investigations are still being completed to ascertain the full reasons for the incident, and further information will be communicated once this process is complete. The image below shows that the pole was situated in a ditch with an adjacent sloping bank.

1. Carry out a thorough visual inspection of the pole, checking for any indications of impaired strength or visual defects.
2. Assess the surrounding ground conditions to ensure that the ground is stable, and that the pole appears to have been planted to the correct depth, and make small excavations at the base of the pole if required.
3. Carry out a hammer test to “sound” the pole for signs of internal decay, by lightly tapping the pole using a hammer, starting from the ground level.
4. Carry out a probe test using a pointed implement, for signs of external decay, again starting from ground level, at any points where decay is suspected.

**If there is any doubt as to the integrity of any pole STOP work immediately and seek further advice.**
