Injury to Overhead Line Surveyor

Issue date	4 th December 2015	Ref. No	UAG035
------------	-------------------------------	---------	--------

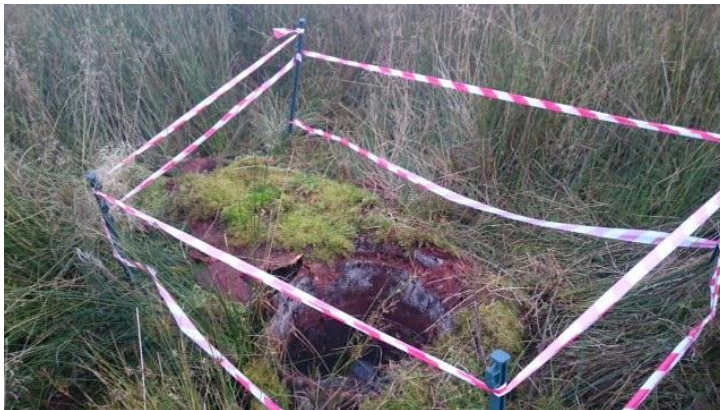
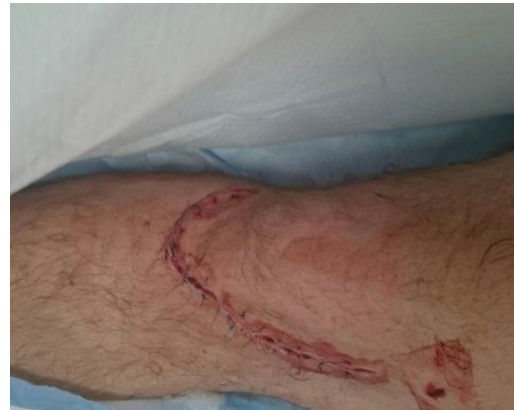
A UK based Network Operator has recently reported a serious injury sustained by an overhead line surveyor while carrying out a line patrol. A wooden board that had been used to cover a well opening collapsed when the surveyor stepped on it. The board was in poor condition and was completely overgrown by grass and moss.

The injury sustained resulted in surgery to repair the patella tendon. The surveyor is now undergoing physiotherapy and will not be able to return to work for a minimum of 8 weeks. The well was on Forestry Commission land and was unmarked.

1. All staff required to cross rough terrain to be alerted to this incident and the danger of unmarked wells.
2. A risk assessment, either generic or site specific, must identify control measures to monitor and communicate with lone workers.
3. Means of communication should be carefully considered particularly if mobile phone signal may be poor.
4. Landowners must be made aware of their obligations regarding hazards on their property.
