## Chainsaw Inflicted Facial Injury

Issue date	24 <sup>th</sup> February 2015	Ref. No	UAG020
------------	--------------------------------	---------	--------

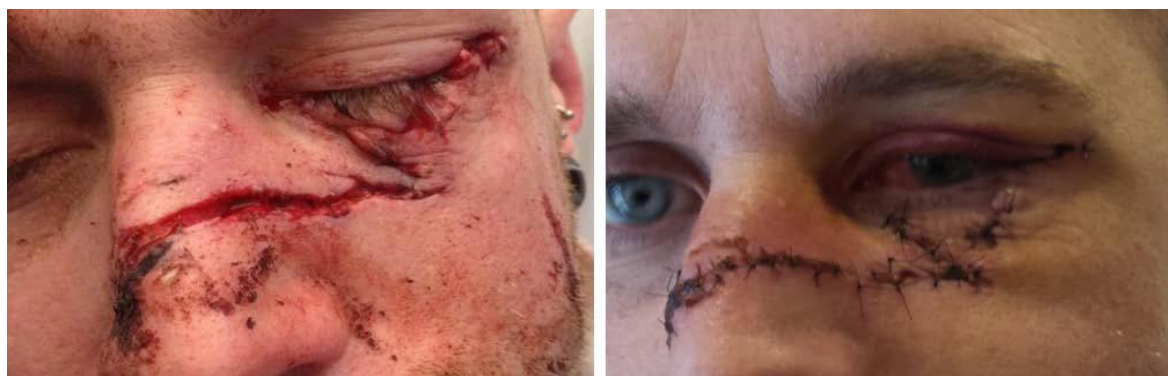
The accident occurred when the operative was cutting vines positioned at head height along an existing fence line. While doing so, his chainsaw came into contact with an adjacent metal chain link fence, which subsequently kicked it back towards his face, with his mesh visor taking a direct impact. This resulted in significant facial injuries (pictured below) which required immediate first aid on site and surgery at hospital.

The operative was both experienced and competent, however, on this occasion it was concluded that time was not taken to fully assess the site. The particular chainsaw had two handles, but due to the position and angle at which the operative was using it, this did not provide sufficient control to counter the kickback.

1. Never become complacent when using chainsaws.
2. Work sites must be sufficiently assessed, in particular for additional hazards that may cause a potential kickback of chainsaws e.g. stumps, stubs, chain-link, rabbit netting etc
3. Select a safe work position so that the body and head are not in line with any kickback
4. Ensure chainsaws are used in a way that will avoid kickback: not allowing the nose to come into contact with obstructions; never over-reaching; keeping the saw below chest height, keeping depth gauges at the correct height and using appropriate chain speed for the material being cut.
