1. All staff working in the vicinity of live overhead lines should be especially vigilant, especially if they are operating plant or machinery that could inadvertently come into contact with that line.
2. Incidents of inappropriate working practices or storage of materials or equipment below or adjacent to overhead lines should be reported immediately, and written guidance should be issued to the landowner by the appropriate party.
3. If a situation is identified that poses an immediate risk to life, you should take all reasonable steps to reduce the level of risk, report the situation to the relevant Control Person and remain on site until assistance arrives to take the appropriate action to make the situation safe.

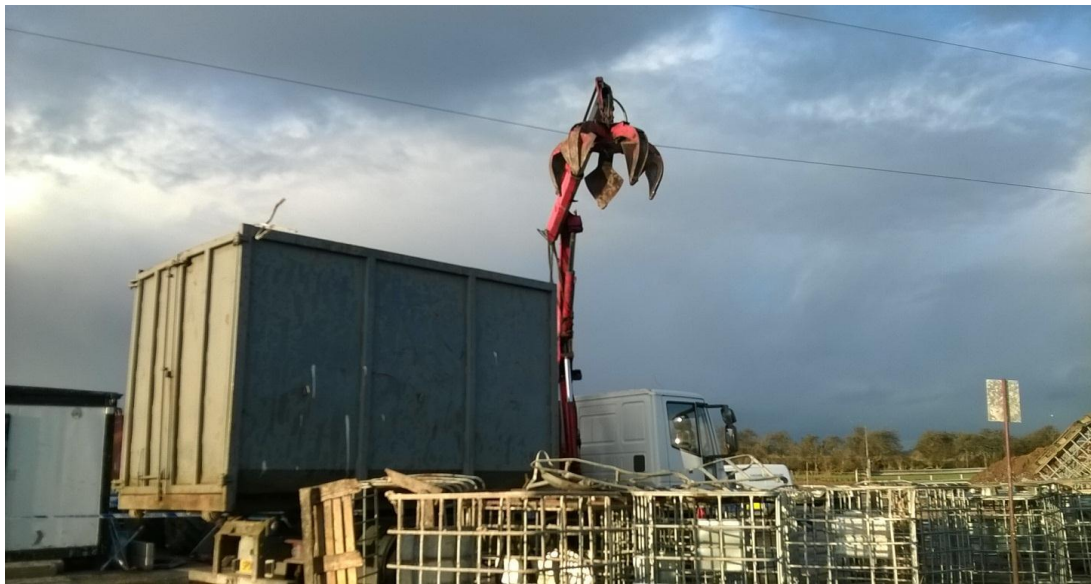
An unfortunate fatality has recently occurred where a third party HIAB lorry driver has inadvertently manoeuvred a HIAB grab arm into a live 11kV overhead power line.

A Panel of Enquiry is currently further investigating the full circumstances of this incident, and their findings will highlight any further learning points in the near future. The investigation has already highlighted that several years ago, during a line inspection of an adjacent section of network, spoil had been identified immediately below a live line. The landowner had been made aware verbally of the dangers of such practices and the spoil at that point was cleared.
