Linesman's mate struck by battery falling from height

Issue date	22 nd June 2015	Ref. No	UAG028
------------	----------------------------	---------	--------

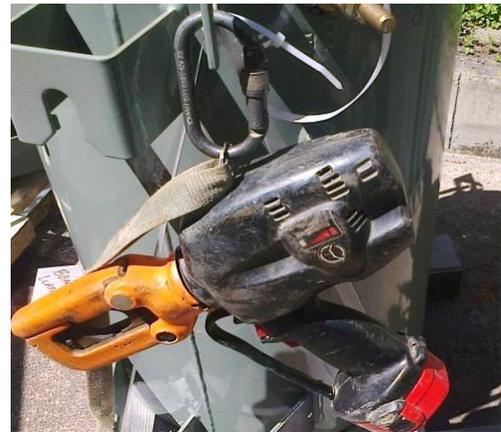
Staff were undertaking work to upgrade a pole mounted transformer, and a compression tool had been left suspended from the lifting eye of the newly installed transformer. As work neared completion, with no-one working aloft, the mate entered the working area to inspect the base of the pole. At the same time the battery in the tool became detached, falling to the ground and striking him on the back of the neck.

1. Carry out thorough pre-use visual inspections of all tools, equipment and PPE prior to use, and if any item shows signs of damage, or does not operate correctly **STOP** and inform your Supervisor.
2. Minimise the amount of tools, equipment and materials required when working at height.
3. Establish an Exclusion Zone, and ensure it is understood by all members of the work party, is documented on the site specific risk assessment, and is controlled by someone on the ground.
4. Ensure all tools and equipment are stored so they can't fall, and remove them once used.
5. Only enter an Exclusion Zone once all work above has stopped, and all tools and equipment have been made secure, and upon leaving ensure staff aloft are aware, so they can continue with any further works.

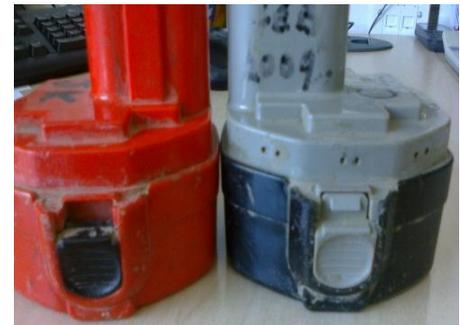
An investigation is currently in progress to determine all of the facts and the root cause, but one area identified is that the battery being used in the crimping tool had defective locking clips that are designed to secure the battery into the tool.
