## Hi-Vis vest becomes entangled in chainsaw starting mechanism

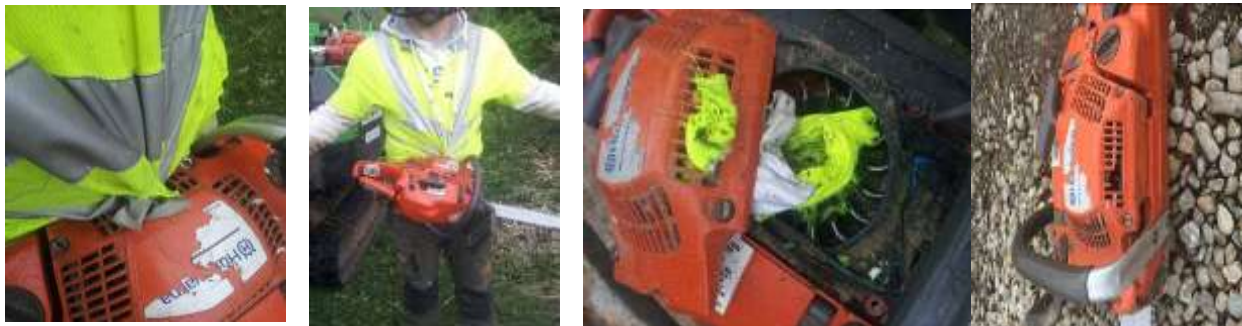
While cutting, a torn section of his high-vis was drawn into the starter housing through broken air intake slots. The material snagged on the flywheel pulling the saw close to his body at full revs. This stopped the engine. The operator was very fortunate and no injuries were sustained.

- ◆ the operators high-vis vest was torn slightly, and,
- ◆ a number of cooling air intake slot guards on the chainsaw were missing

1. Ensure that all PPE is in good condition, properly fastened and free from snag hazards or hanging materials that can become entangled in starting mechanisms or the moving parts of the saw
2. Ensure that all guards on work equipment are intact, without defects, fit for purpose and meet the manufacturers' standards.
3. Report defects in PPE immediately and request that they are replaced as required
4. Ensure that all work equipment is thoroughly checked pre-use, and if defective, it is quarantined and not used until the defects are rectified
5. Missing guarding on any equipment, including starter housings, produces the potential for serious accidents, including the entry of fingers onto moving components. Never use equipment with damaged or missing guards - replaced them immediately
