## Mobile Elevating Work Platform Overturns

An incident has recently occurred with a tree cutter receiving serious injuries when the Mobile Elevating Work Platform (MEWP) he was working from overturned. Thorough investigations are currently being completed to ascertain the full reasons for the incident.

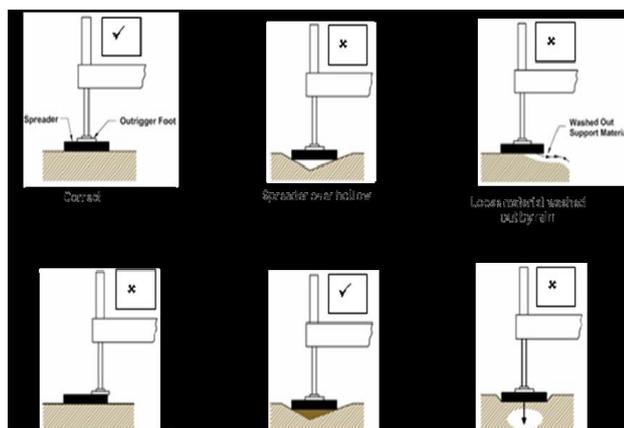
1. All staff shall be trained and competent in the use of a MEWP and hold a current certificate
2. It is essential that an assessment of ground conditions are made before travelling, setting up and using a MEWP on any surface
3. It is mandatory that suitable spreader plates should always be used under the outrigger feet irrespective of the apparent ground conditions
4. The spreader pads must always be level and the feet centred on the pad (see below)

5. Where very poor ground conditions are found advance works providing additional foundations, such as timber mats, proprietary mats, steel grillages or concrete pads may be required, before the MEWP outriggers are deployed. If timbers are used they must be of adequate thickness
6. When working near a trench or slope there may be increased risk of subsidence or machine slippage
