Climbing iron gaff pierces 11kV cable termination

Issue date	17 th August 2015	Ref. No	UAG026
------------	------------------------------	---------	--------

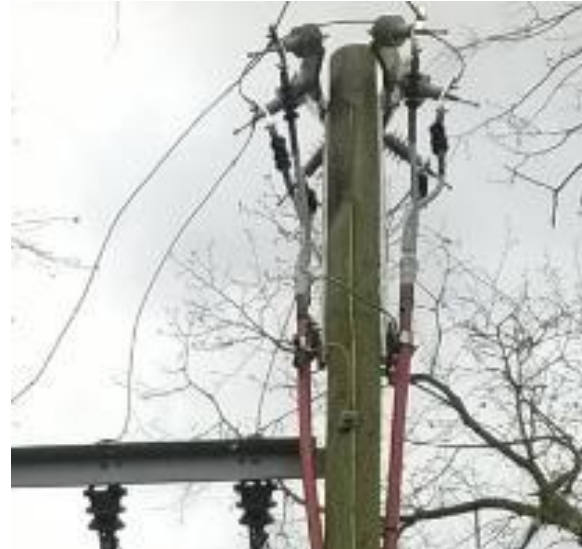
Whilst work was being undertaken to replace one of two 11kV cable terminations that had failed on a free-standing transformer pole, a linesman inadvertently put one of his climbing irons into a healthy, isolated 11kV cable whilst manoeuvring on and around the pole.

1. The first consideration shall be to use a Mobile Elevated Work Platform (MEWP)
2. If this is not reasonably practicable, then consideration shall be given to using an approved ladder
3. If neither of these methods are reasonably practicable, then climbing irons and approved personal fall arrest equipment shall be used

Fortunately, on this occasion no injuries occurred due to the cable being isolated and earthed. However, if any circumstances arise where you are unable to carry out work within an approved technique, **STOP** work immediately and seek further advice from your Line Manager, Supervisor or Health and Safety Advisor.
