## Vegetation Contractor Fall from Height 7 September 2020

On the 7th September 2020 at approximately 10:45 a vegetation contractor working for SPEN in the SP Manweb licence area fell approximately 10 metres from a tree he had been working in.

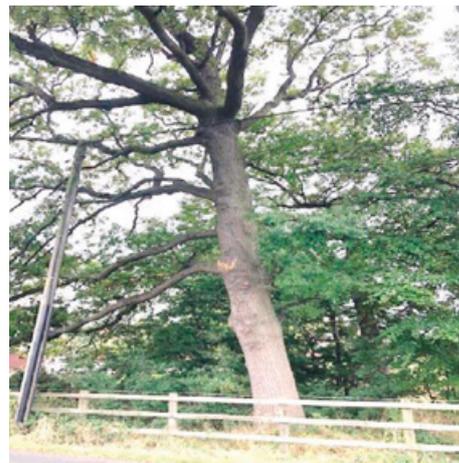
The IP had been using two climbing systems to ascend the tree and carry out the cutting work. While descending the tree after completing the work, the two systems the climber was using for anchor points became detached from his harness resulting in the fall.

Injured person fell approximately 10 metres

- All persons carrying out tree climbing operations must follow [HSE document AFAG401 'Tree-climbing Operations'](#)
- Climbers must be securely attached to two anchor points at all times
- Ensure all working at height equipment is checked before use and is being used correctly as per manufacturer's guidance
- All staff must be trained and competent on the use of mechanical devices for climbing operations

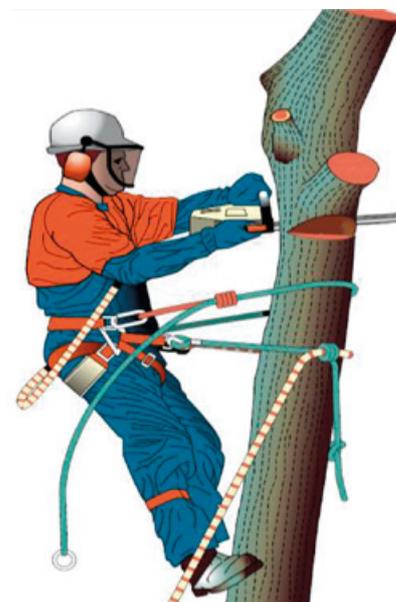
All climbers must have two points of attachment at all times
